SUBJECT: RAPID RESPONSE TRANSMITTAL/SERVICE ACTION #09-037
Passenger Side - Heated Seat Wire Retention

2008 - 2009 (LC) Challenger

2008 - 2009 (LZ) SRT8 Challenger

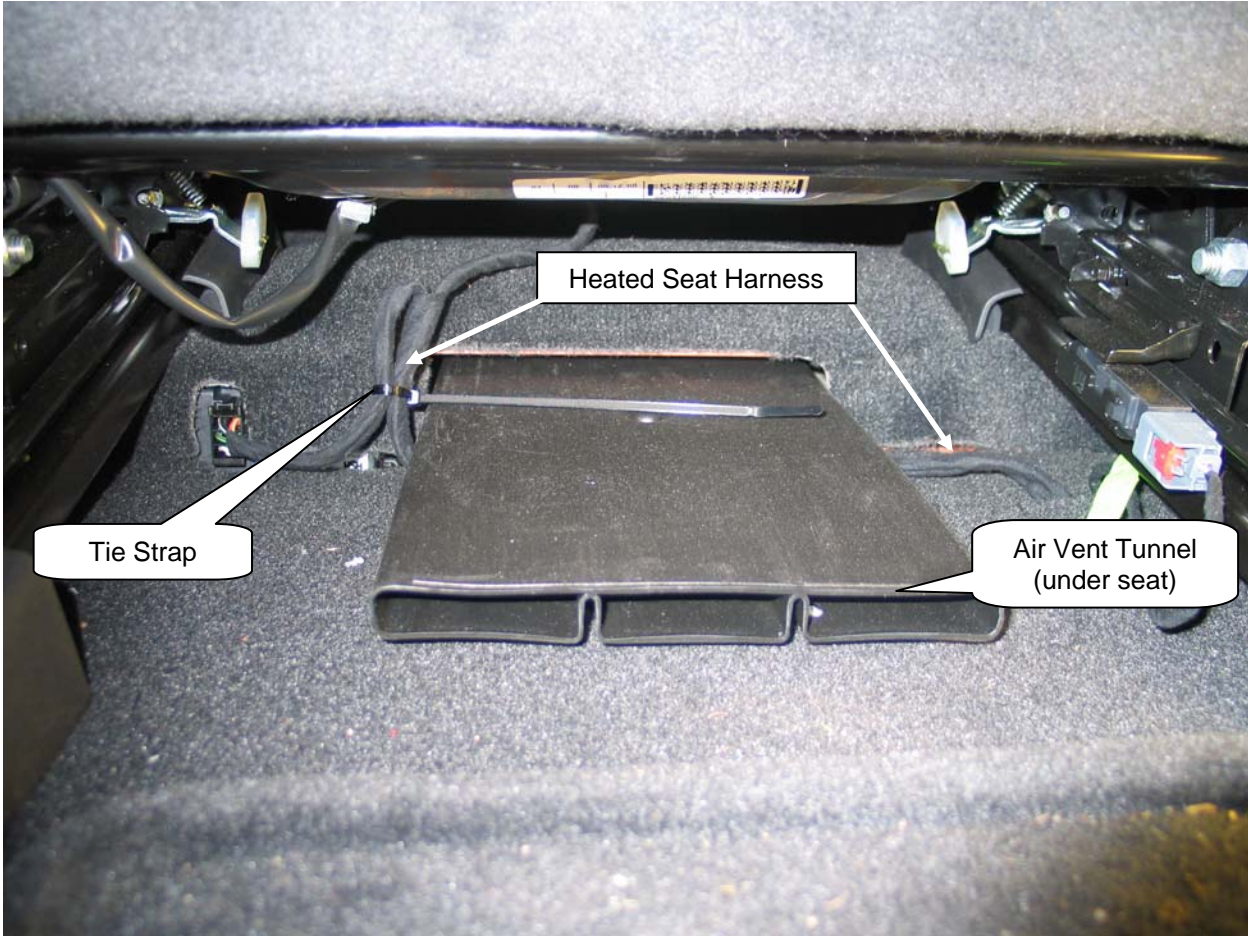
Figure 1

A number of vehicles with heated seats (Sales Code JPM) were shipped with the passenger side heated seat wire positioned where it could pull on the electrical connector and unplug the heated seat module. Dealers are required to secure the wire out of the way with a tie strap.

1. Position right side (passenger) seat all the way forward and tilt seat back all the way forward.
2. Gather up the excess length of wire from under the air vent tunnel toward the center of the vehicle (Fig.1).
3. Add the tie strap to keep the harness in place (Fig. 1).
4. Return vehicle to Inventory or the Customer.
