August 10, 2009

SUBJECT: RAPID RESPONSE TRANSMITTAL/SERVICE ACTION #09-046
Deck Lid Misalignment

2009 (LC) Challenger

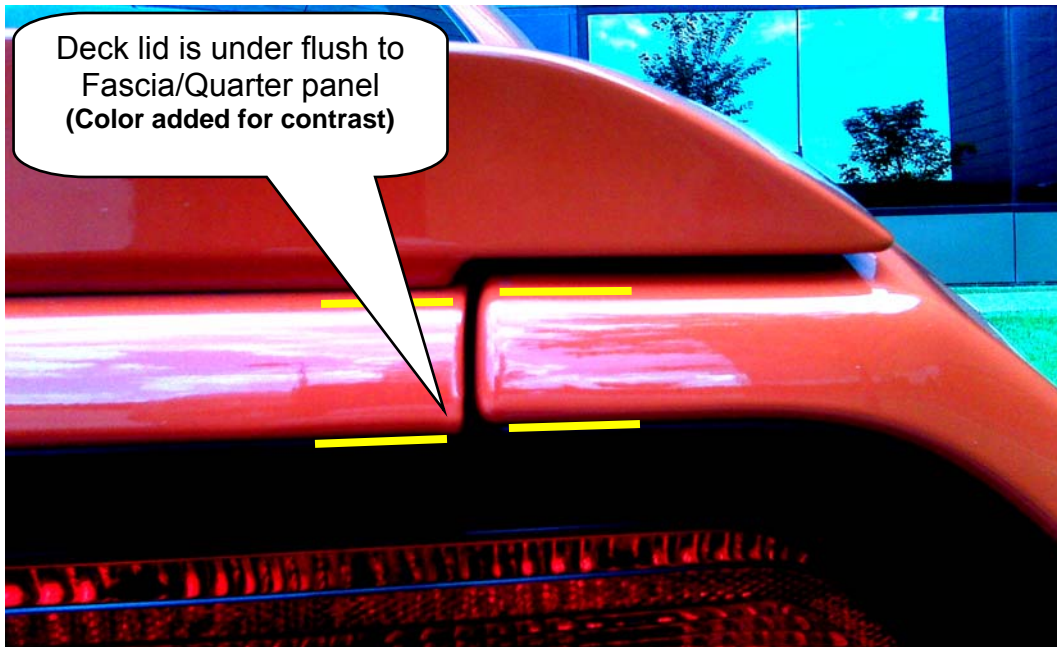
A number of vehicles may have been built with the rear deck lid improperly adjusted during assembly. The out of adjustment condition occurred primarily on the right side of the deck lid and would be noticed as an over flush condition on vehicles without a spoiler and under flush on vehicles with a spoiler. Dealers are required to inspect and adjust the latch and / or hinges to obtain the proper fit / finish.

Figure 1- Incorrect Alignment

2. Refer to the fit objectives outlined in DealerConnect > Service Info > 23-Body > Body Structure > Gap and Finish > Specifications > Gap and Flush.
3. Adjust the latch striker position as necessary to achieve proper deck lid latch operation.
4. Adjust the deck lid hinge positions and upper over slam bumpers as necessary to achieve proper spacing and operation.

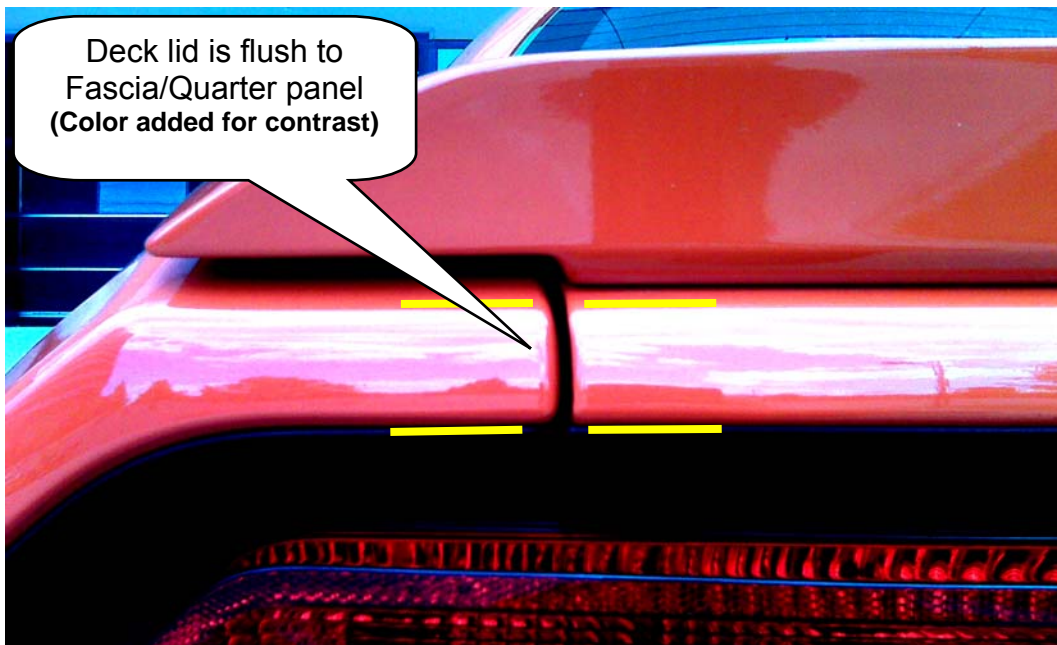
Figure 2- Correct Alignment
