TO: ALL DODGE DEALERS

SUBJECT: RAPID RESPONSE TRANSMITTAL #09-060
Sun Visor Vanity Mirror Cover Looseness

2009 (JC) Journey
2009 (LC) Challenger

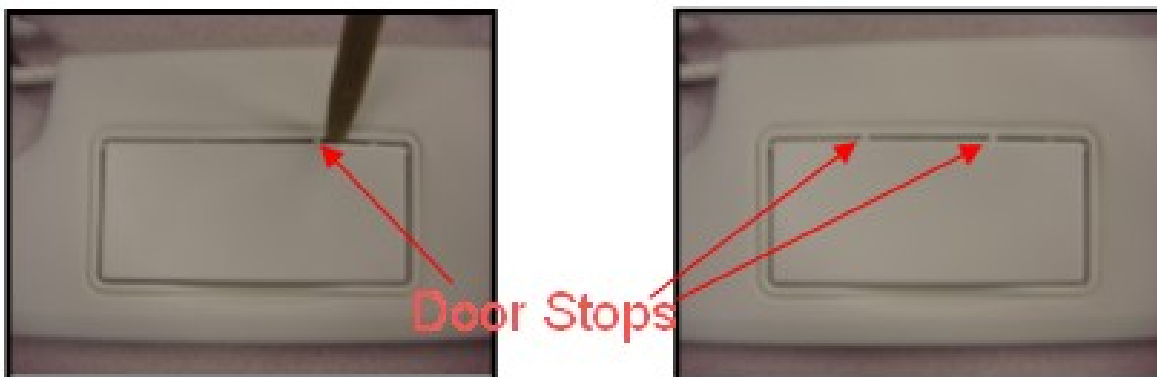
Figure 1

A number of vehicles shipped with Sun Visor Vanity Mirrors were assembled with contaminated lubricant. The lubricant will soften the plastic of the mirror cover and cause it to become loose or fall off. Dealers are required to remove the covers, clean the pivot areas on the visor and install new covers.

1. Lower the visor to gain access to the vanity mirror.
2. Insert a trim stick between the upper edge of the cover and mirror bezel. Gently pry the lid stops out of the bezel (Fig 1).
