Revised August 2010

Dealer Service Instructions for:

Safety Recall K08

Wireless Ignition Node Receiver

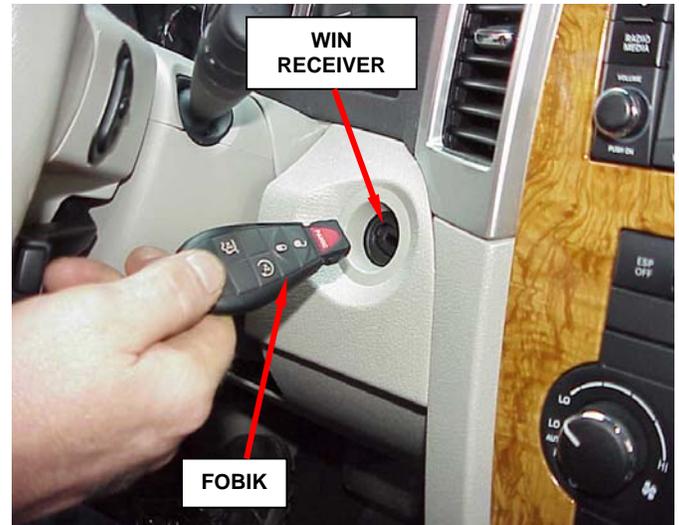
Figure 1 – FOBIK and WIN Receiver

1. Insert FOBIK in the WIN receiver.
2. Place the ignition in the “RUN” position.
3. Shift the gear shift lever from the “PARK” position to the “NEUTRAL” position.
4. With the gear shifter in the “NEUTRAL” position, attempt to turn the FOBIK counterclockwise to the “OFF” position and remove the FOBIK from the WIN receiver.

- If the FOBIK can be removed from the WIN receiver with the gear shift lever in “NEUTRAL,” continue with one of the following sections:
 - B. (DS/DJ/D2) Ram 1500/2500/3500 Truck WIN Replacement
 - C. (LC/LX) Dodge Challenger/Charger & Chrysler 300 WIN Replacement
 - D. (WK/XK) Jeep Grand Cherokee & Commander WIN Replacement
 - If the FOBIK cannot be removed with the gear shift lever in “NEUTRAL,” continue with Step 5 of this procedure.
5. Place the gear shift lever in the “PARK” position and remove the FOBIK from the WIN receiver.
 6. Repeat Steps 1 through 4 of this procedure 49 times.
 - If the FOBIK can be removed while the gear shift lever is in the “NEUTRAL” position during any of the 50 test cycles, replace the WIN receiver.
 - If the FOBIK cannot be removed while the gear shift is in the “NEUTRAL” position after 50 test cycles, return the vehicle to the customer.
