Revised May 2013

Safety Recall N07 / NHTSA 13V-118 Seat Wiring Harness Connectors

2011-2012 (LC) Dodge Challenger
(LD) Dodge Charger
(LX) Chrysler 300

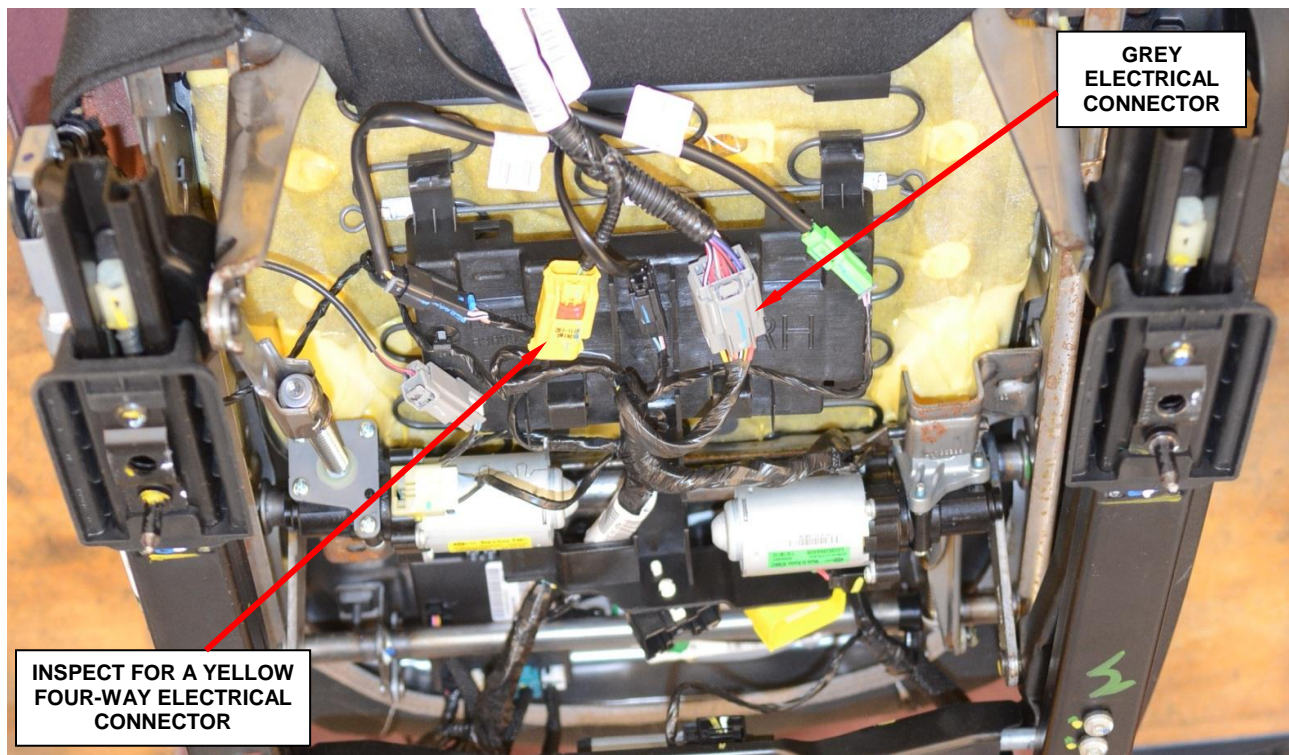
Figure 1 – Inspect for a Yellow Electrical Connector Under Each Front Seat

1. Move both front seats to the full forward position.
2. Using an inspection mirror look under the back of the seat cushion for a yellow four-way electrical connector (Figure 1):
 - If the yellow four-way electrical connectors have been removed from both front seats and the wires have been spiced together, no further action is required. Return the vehicle to the customer.
 - If one or both front seats have yellow two-way connectors, the seat(s) with the two-way connector does not require repair. If both seats have a two-way connector no further action is required. Return the vehicle to the customer.
 - If one or both front seats have yellow four-way electrical connectors, the seat with a yellow four-way electrical connector must have a new airbag overlay wire harness installed. Continue with **Section B. Install Airbag Overlay Wire Harness.**

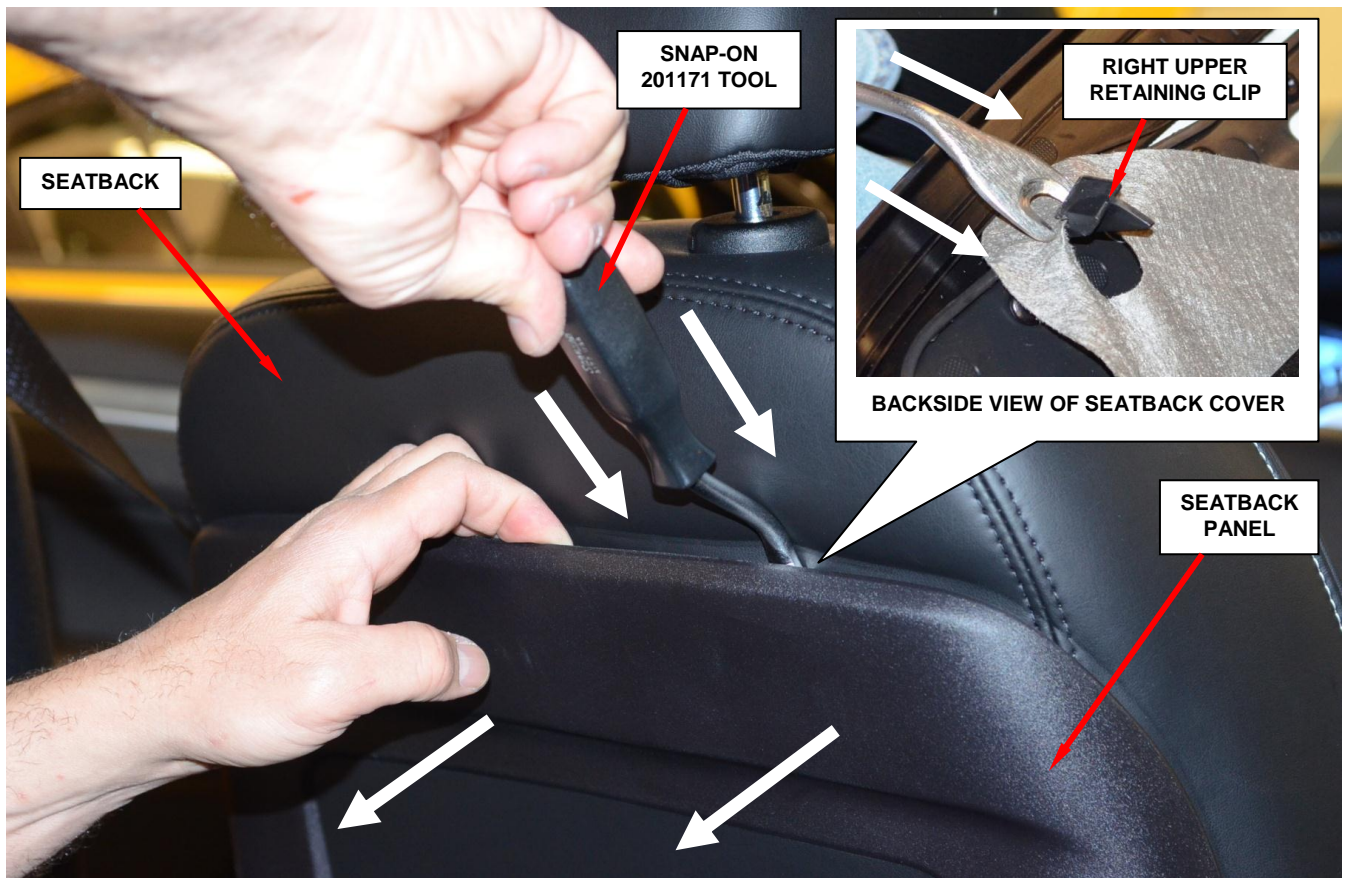
Figure 2 – Disengage the Two Upper Retaining Clips

5. Remove both seatback covers from the front seats using the following procedure:
 - a. Insert a Snap-on 201171 tool, or equivalent, at the top of the seatback panel and push down on the upper retaining clips to disengage the two clips while pulling outward slightly on the top of the seatback panel (Figure 2).

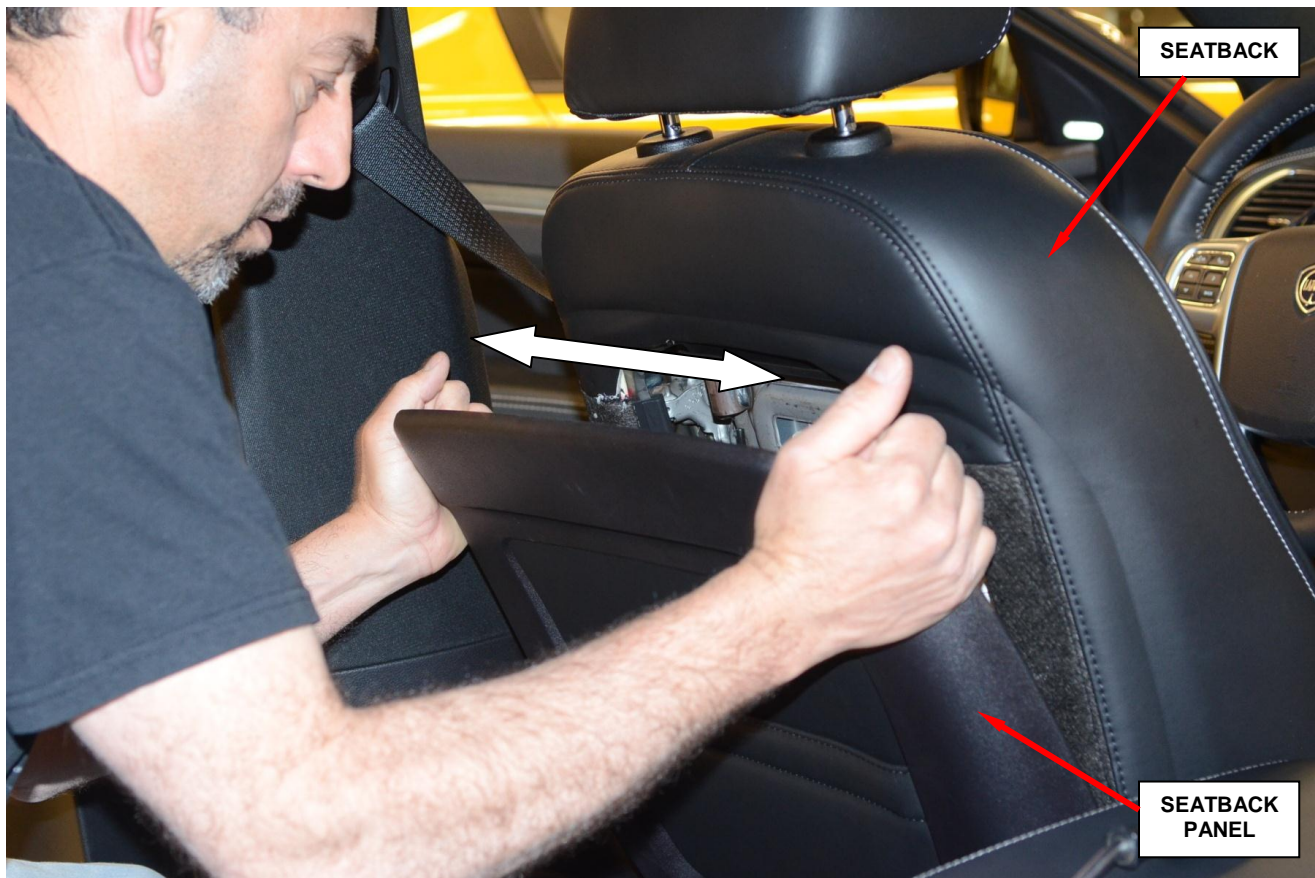
Figure 3 – Wiggle Seatback Panel Right and Left While Pulling Rearward

- b. Once the two upper retaining clips are disengaged, wiggle the seatback panel right and left, while pulling the seatback panel away from the seatback, to disengage the side clips (Figure 3).

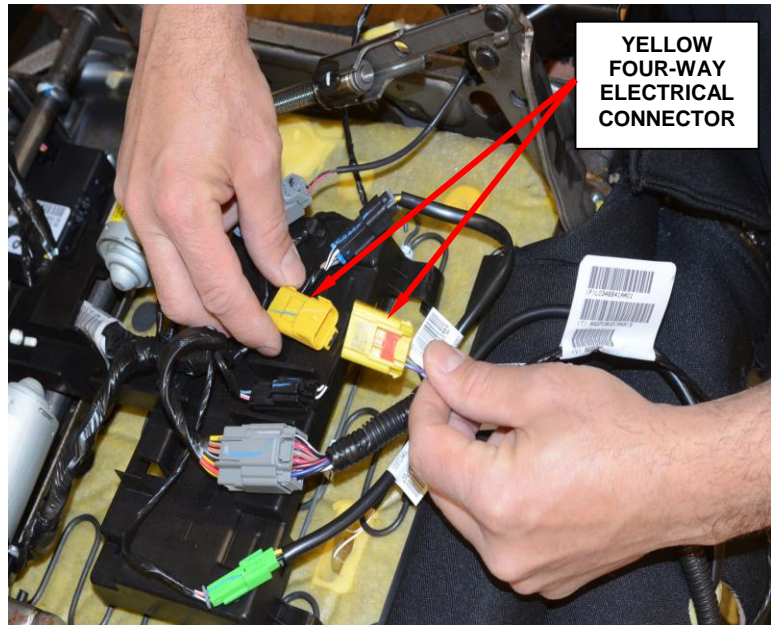
Figure 4 – Disconnect Yellow Four-Way Electrical Connector

6. Disconnect the yellow four-way electrical connector from the seat cushion wiring harness (Figure 4).

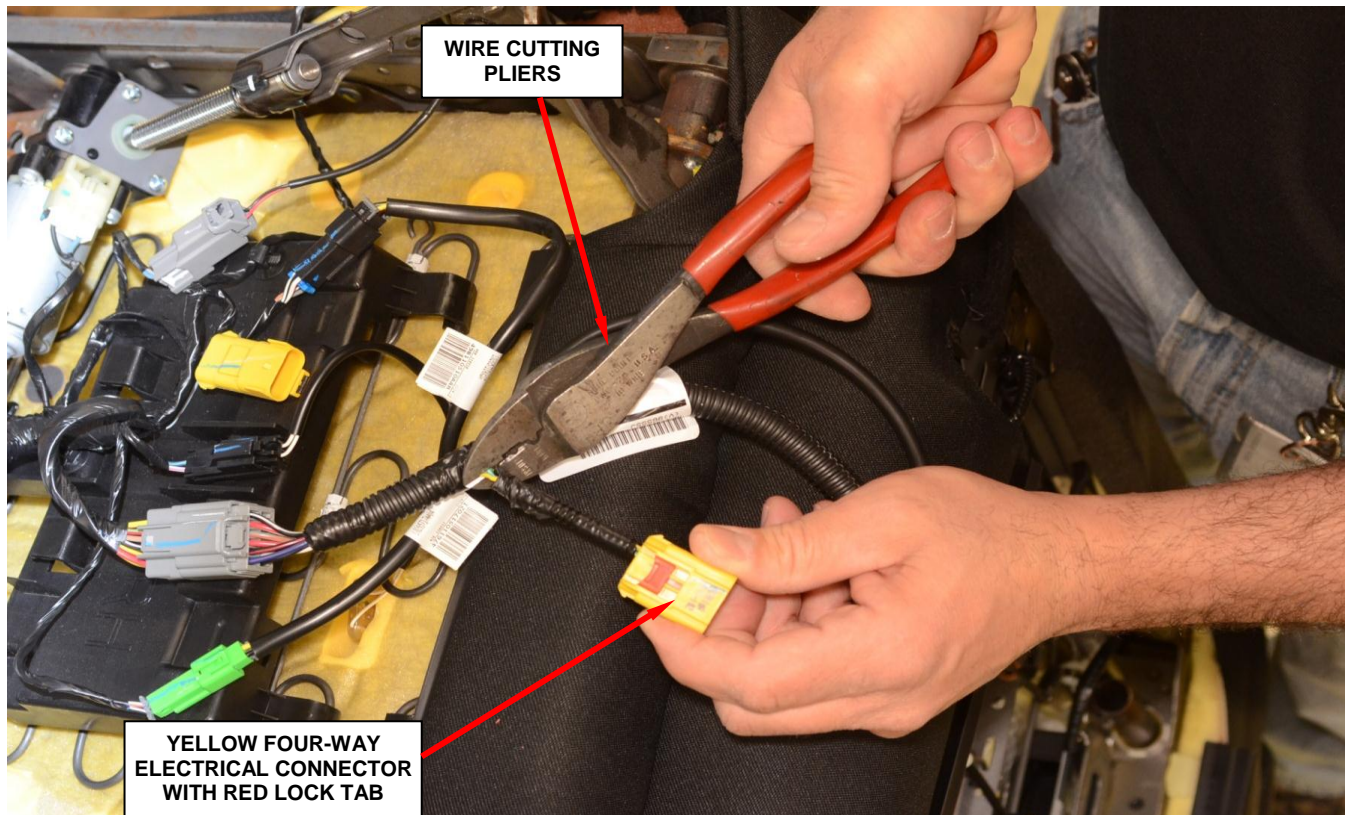
Figure 5 – Cut Off and Discard the Yellow Four-Way Wiring Harness Side Electrical Connector (Except Challenger Right Side Front Seat)

7. For all models except Challenger right side front seat, cut off and discard the original wiring harness side yellow four-way electrical connector (Figure 5).

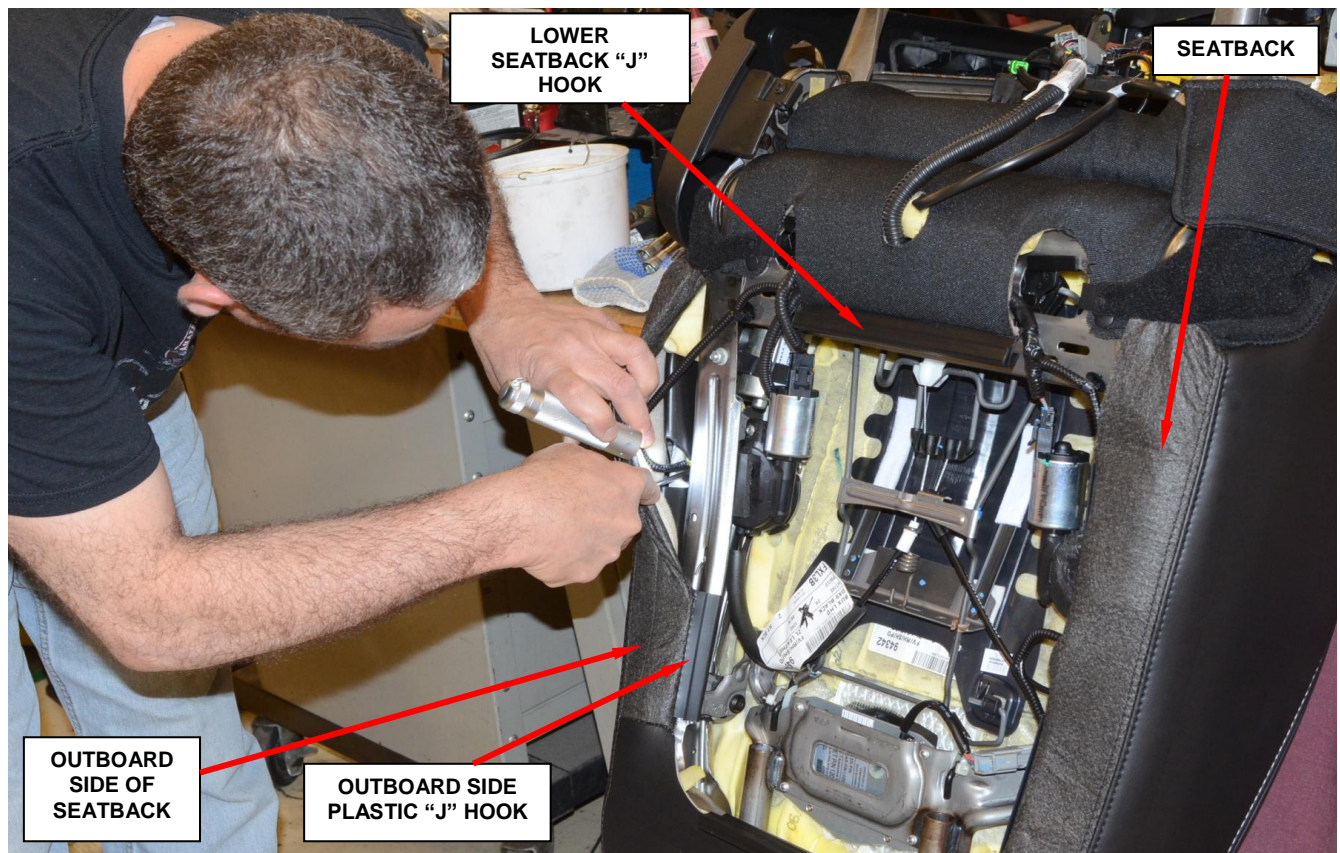
Figure 6 – Disconnect Yellow Squib Wiring at Airbag Module

8. Disconnect the outboard side seatback plastic “J” hooks to gain access to the airbag module squib connector (Figure 6).
9. Disconnect the lower seatback plastic “J” hook (Figure 6).
10. Disconnect the yellow squib connector at the airbag module (Figure 6).

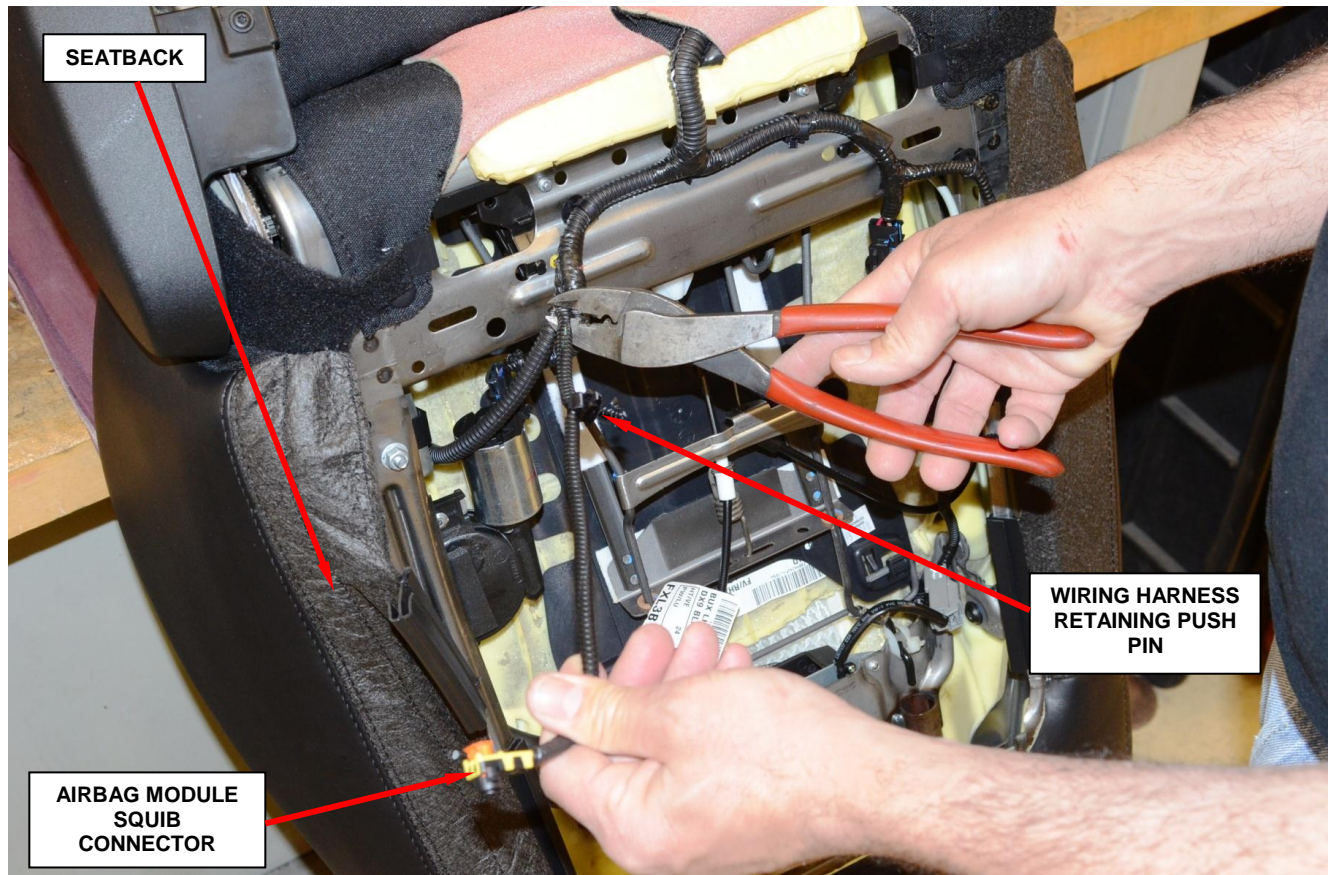
**Figure 7 – Cut Off Original Airbag Module Wiring
(Except Challenger Right Side Front Seat)**

11. Disconnect the airbag wiring harness retaining push pin(s) at the seat frame.
12. **For all models except Challenger right side front seat**, cut off and discard the original airbag module wiring (Figure 7).
13. **For Challenger right side front seat only**, remove and discard the original airbag module wiring harness.
14. Connect the new squib connector from the overlay harness to the airbag module. Be sure to engage the red connector lock.

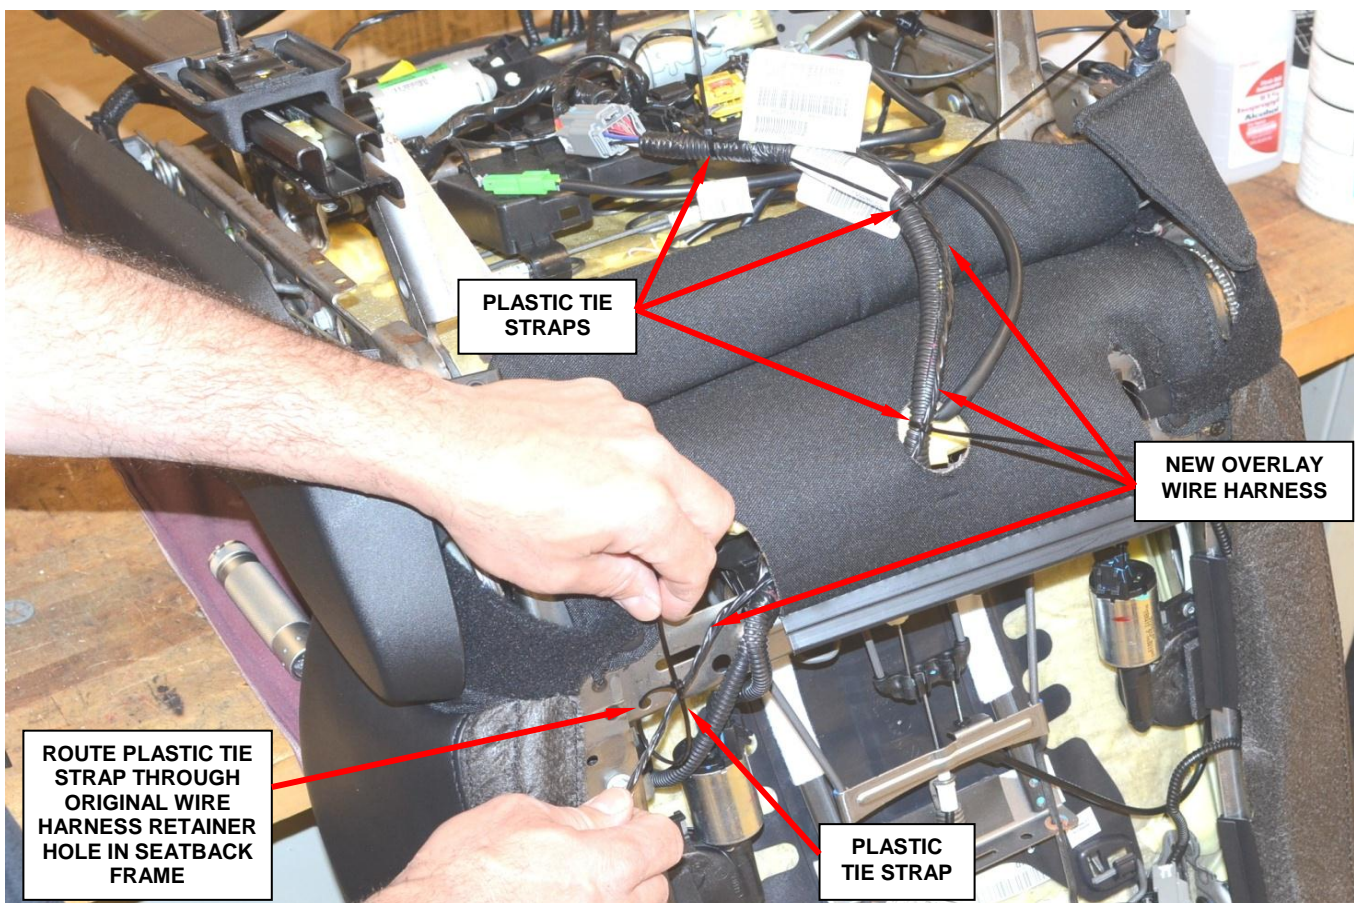
Figure 8 – Route and Tie Strap Overlay Wire Harness to the Original Wiring Harness (Except Challenger Right Side Front Seat)

15. Route the new airbag module overlay wire harness along the seatback (Figure 8).
16. Connect the new yellow four-way electrical connector to the seat cushion wiring harness. Be sure to engage the red connector lock.
17. Using the supplied tie straps, secure the airbag module overlay wire harness to the seatback frame and original wiring harness.
