NUMBER: 08-081-15

GROUP: Electrical

SUBJECT:

Unable To Register With Uconnect

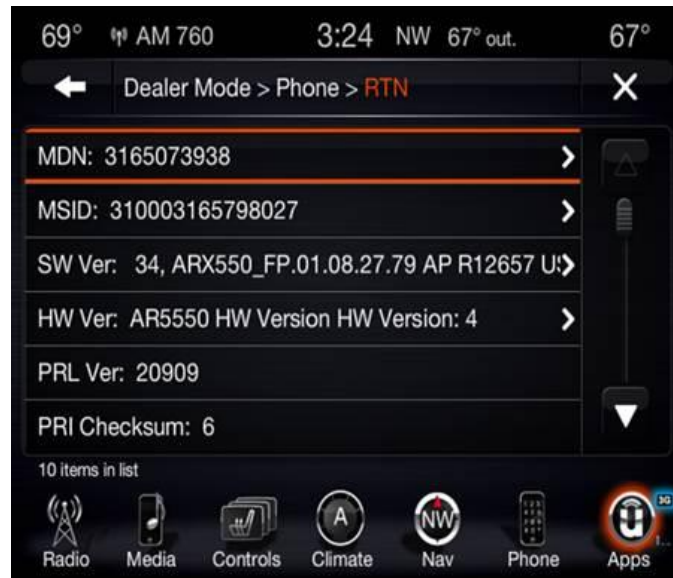
Fig. 4 MDN Number

NOTE: At times when going into the ##RTN# screen the MDN number might remain listed as “NULL”. If this occurs, back out of the screen, re-enter the ##RTN# screen and it will populate the MDN number.

6. Record the MDN number for the STAR case.
