NUMBER: 05-002-09 REV. B

GROUP: Brakes

Pre Delivery - Front Brake Rotor Corrosion Inspection & Procedure

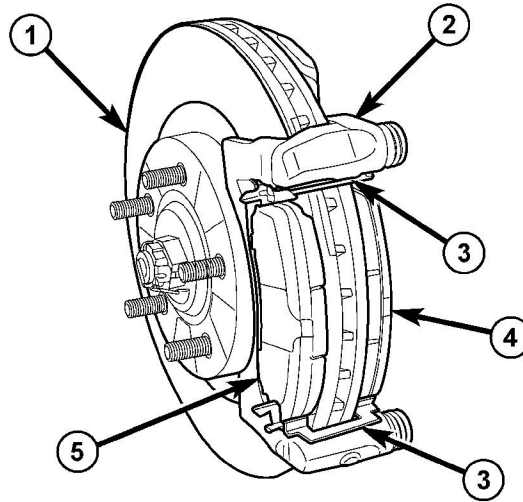
Fig. 1 FRONT BRAKE PADS

1. During vehicle prep, **just prior to customer delivery**, inspect the vehicle build date (MDH) on the certification label located on the inside of the driver's door opening.
2. Is vehicle equal to or greater than 90 days old from the build date (MDH)?
 - a. Yes >> proceed to [Step #3](#).
 - b. No >> This Service Bulletin does not apply. Continue with normal pre-delivery prep.
3. Drive vehicle in the parking lot and make at least 3 hard stops.
4. Inspect the front rotor surfaces and look for brake pad marks on the rotors (outline of brake pads on the rotor surface).

-
- 5. Is there an outline or footprint of a brake pad present on the inner or outer rotor surface?
 - a. Yes >> proceed to [Step #6](#).
 - b. No >> The remaining portion of this Service Bulletin does not apply.
 - 6. Using a PSE approved on-vehicle brake lathe, lightly resurface the rotor that showed the witness mark only.
