NUMBER: 08-019-12

GROUP: Electrical

Flash: Hands Free Module Customer Satisfaction Enhancements

This Bulletin involves performing a USB service flash of the Hands Free Module (HFM).

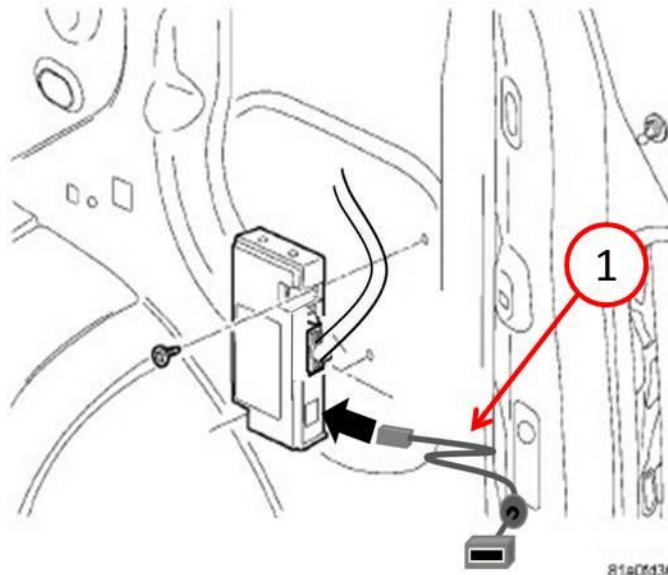
Fig. 11 USB Harness Connection

1 - USB harness PN# 82212160 or 68086985AB.

1. Access the HFM Module by following steps 1 through 4 in DealerConnect / TechCONNECT> Group 08 - Electrical> 8T - Navigation/Telecommunications> MODULE, Hands Free (HFM)> Removal — REMOVAL.
2. Do **NOT** disconnect the electrical connectors from the HFM.
3. Connect the USB harness (PN# 82212160 or 68086985AB.) as shown in ([Fig. 11](#)).
4. Reconnect the battery.
5. Return to the Perform Software Reflash Procedure [Step #14](#).
