NUMBER:	08-036-11
GROUP:	Electrical
DATE:	June 29, 2011

iPod and iPhone Compatibility Issues

This Bulletin involves performing a USB service flash of the Hands Free Module (HFM).

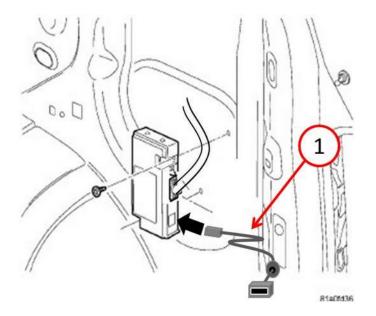
Fig. 8 USB Harness Connection

1 - USB harness PN# 82212160

- Access the HFM Module by following steps 1 through 4 in DealerConnect / TechCONNECT> Group 08 - Electrical> 8T - Navigation/Telecommunications> MODULE, Hands Free (HFM)> Removal — REMOVAL.
- 2. Do **NOT** disconnect the electrical connectors from the HFM.
- 3. Connect the USB harness (PN# 82212160) as shown in (Fig. 8).
- 4. Reconnect the battery.
- 5. Return to the Perform Software Reflash Procedure Step #3.
