**NUMBER:** 08-050-12

**DATE:** August 09, 2012

Flash: Hands Free Module Prompts Begin To Play Without Pressing The Phone Or Voice Recognition Button

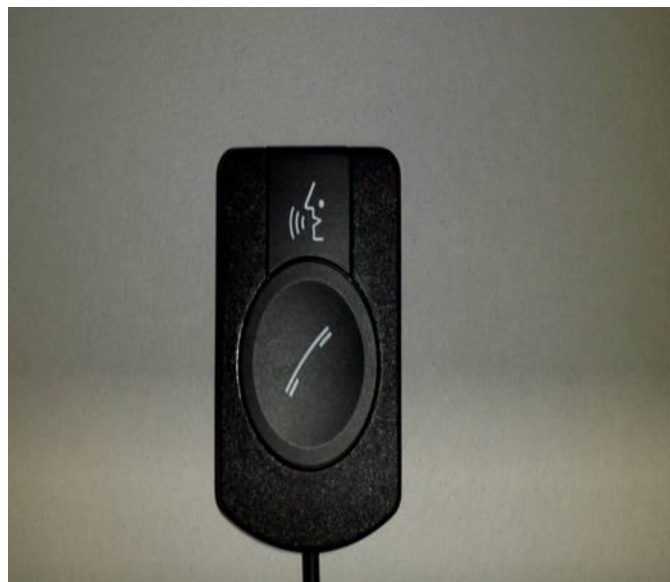
***Fig. 1 Stand alone Phone and VR button***

**NOTE:** One way to tell if a HFM kit was added to the vehicle is, there will be a stand alone VR/Phone and phone button . Also there will be NO VR/Phone button on the steering wheel or on the radio.([Fig. 1](#)).

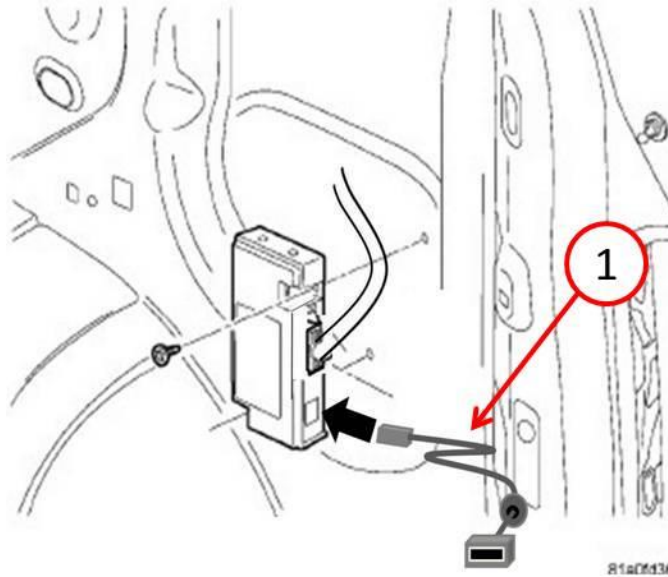
**Fig. 12 USB Harness Connection**

1 - USB harness PN# 82212160 or 68086985AB.

17. Do **NOT** disconnect the electrical connectors from the HFM.
18. Connect the USB harness (PN# 82212160 or 68086985AB.) (Fig. 12).
19. Proceed to [Step #21](#).
