NUMBER: 08-050-12 REV. A

GROUP: Electrical

DATE: October 30, 2012

Flash: Hands Free Module Prompts Begin To Play Without Pressing The Phone Or Voice Recognition Button

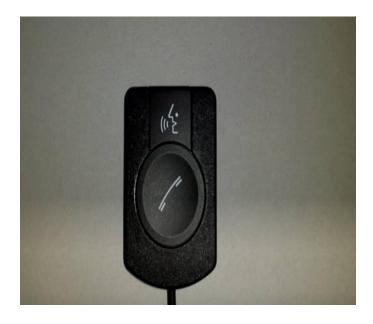
NOTE: One way to tell if a HFM kit was added to the vehicle is, there will be a stand alone VR/Phone button. Also there will be NO VR/Phone button on the steering wheel or on the radio.(Fig. 1).

Fig. 1 Stand alone Phone and VR button

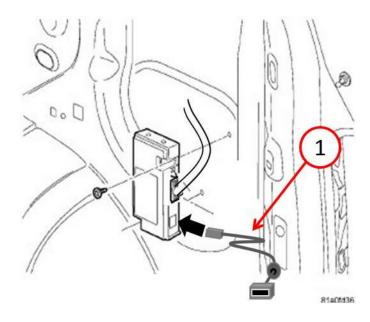
Fig. 12 USB Harness Connection

1 - USB harness PN# 82212160 or 68086985AB.

- 19. Do **NOT** disconnect the electrical connectors from the HFM.
- 20. Connect the USB harness (PN# 82212160 or 68086985AB.) (Fig. 12).
- 21. Proceed to Step #23.
