NUMBER: 18-031-11

DATE: June 16, 2011

MIL Illumination for P0128 - Thermostat Rationality

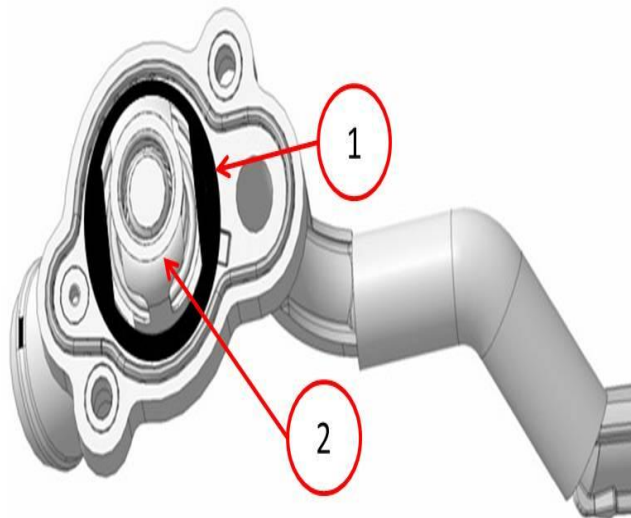
Fig. 1 Shim

This condition may be caused by the block retaining feature for the thermostat not holding the thermostat in place. This causes the thermostat to tip into the engine block opening allowing coolant to pass through without going through the thermostat. With the thermostat

out of position the system will set this DTC.

1. Remove the thermostat housing following the detailed repair procedures available in DealerCONNECT/TechCONNECT group 7 - Cooling > Engine > Thermostat removal procedure.
2. Install shim over the thermostat ([Fig. 1](#)).

NOTE: Shim when installed may be a tight fit over the thermostat.

- 1. Replace the thermostat housing following the detailed repair procedures available in DealerCONNECT/TechCONNECT group 7 - Cooling > Engine > Thermostat removal and installation procedures.
- 2. Install shim following the instructions included with the part (Fig. 1).
