NUMBER: 23-006-09

Decklid Spoiler Fit

2008 (LC) Challenger — SRT8

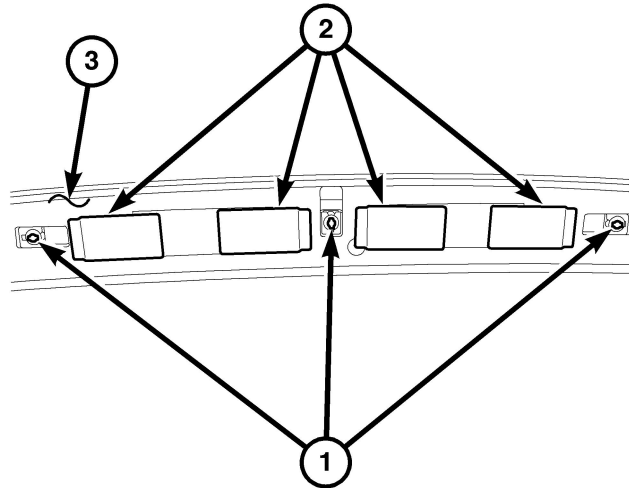
Fig. 1 MOUNTING SURFACE OF THE SPOILER

Some SRT8 decklid spoilers may have a gap between the deck lid and spoiler due to incomplete wet out of the tape attaching the spoiler to the decklid.

1. Remove the rear spoiler using Trim Stick C-4755.
2. Remove and dispose of the three clips and replace with the new clips included in kit p/n 68055947AA as shown in (fig 1)
3. Wipe the mounting surface of the spoiler with isopropyl alcohol prior to tape installation.
4. Apply 3M 06396 adhesion promoter and/or equivalent to the areas where tape will be applied to the spoiler.
5. Install four pieces of tape from kit p/n 68055947AA as shown in (fig 1)

- 6. Clean the decklid surface with isopropyl alcohol prior to installation.
- 7. Reinstall the spoiler

NOTE: Apply downward pressure to fully engage the new clips and ensure good adhesion between the spoiler and deck lid.
