GROUP: Electrical

DATE: April 06, 2011

Loss Of Communications With HFM

This Bulletin involves performing a USB service flash of the Hands Free Module (HFM).

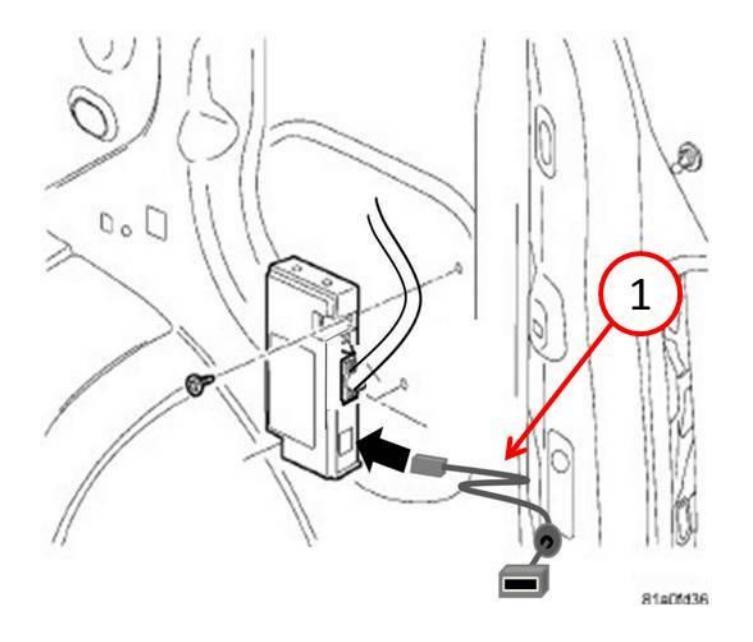
Fig. 1 USB Harness Connection

1 - USB harness PN# 82212160

- Access the HFM Module by following steps 1 through 4 in DealerConnect / TechCONNECT> Group 08 - Electrical> 8T - Navigation/Telecommunications> MODULE, Hands Free (HFM)> Removal — REMOVAL.
- 2. Do **NOT** disconnect the electrical connectors from the HFM.
- 3. Connect the USB harness (PN# 82212160) as shown in (Fig. 1).
- 4. Reconnect the battery.
- 5. Return to the Perform Software Reflash Procedure Step #3.
