NUMBER: 23-017-11

Missing T-Handle Shift Knob, Bright Stainless Steel Pedal Kit, Embroidered Floor Mats, Car Cover And Stainless Steel Door Sills

2011 (LC) Challenger

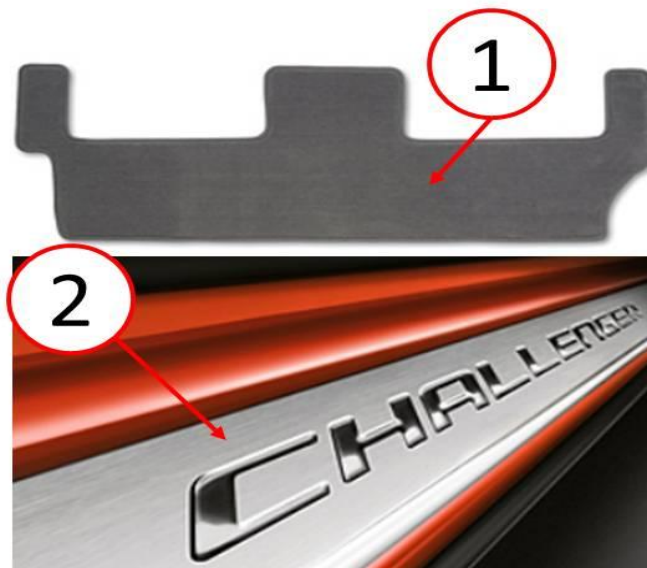
**Fig. 1 Inspection**

1. Inspect the vehicle for a t-handle shift knob (Automatic Transmission Only) and bright stainless steel pedal kit (Automatic Transmission Only). Additionally inspect for floor mats, car cover, door sills with the Challenger logo embroidered or stamped on the part (Fig. 1) (Fig. 2).

- 1 - Rear Seat Floor Mat
 - 2 - Door Sill
-

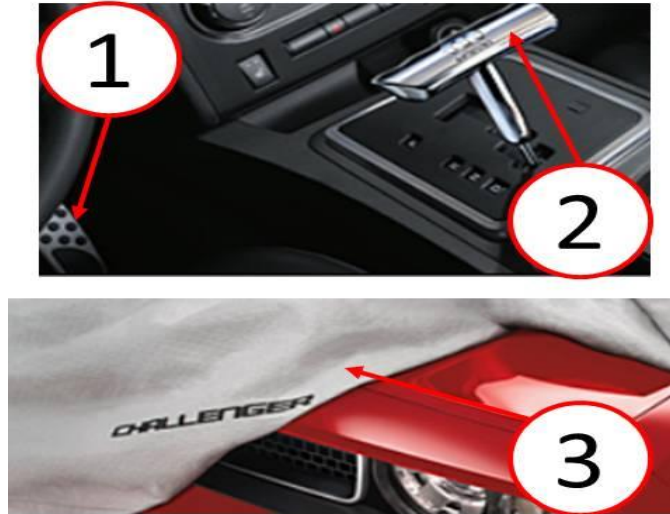
Fig. 2 Inspection

- 1 - Pedal Kit
- 2 - T-Handle Shift Knob
- 3 - Car Cover

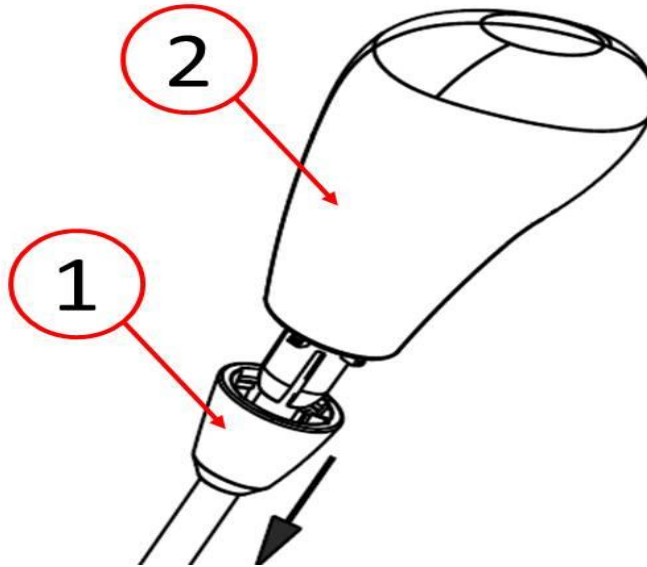
Fig. 3 Shift Knob

- 1 - Retaining Clip
 - 2 - Shift Knob
-

4. Remove the existing shift knob as shown in (Fig. 3).

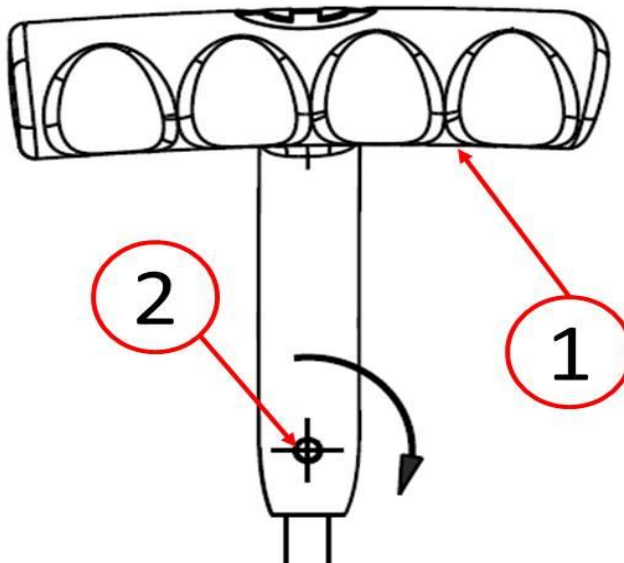
Fig. 4 T-Handle Shift Knob

- 1 - T-Handle Shift Knob
 - 2 - Set Screw
-

5. Install the new T-handle shift knob by rotating it into position and securing the set screw as shown in (Fig. 4).

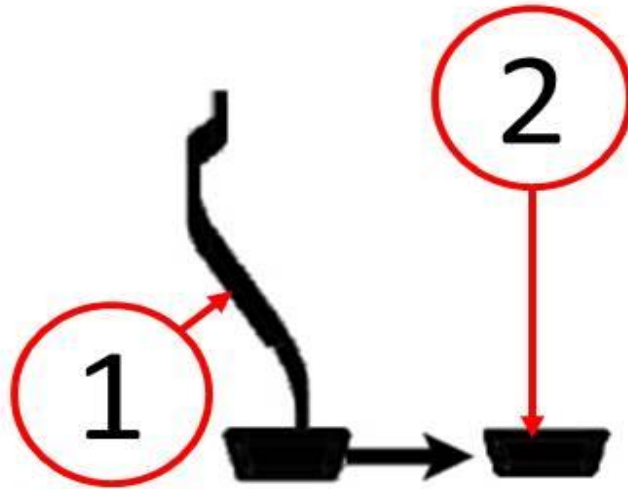
Fig. 5 Pedal Overlay - Brake Pedal Shown

- 1 - Brake Pedal
 - 2 - Brake Pedal Insert
-

6. Remove the current accelerator and brake pedal insert (Fig. 5).

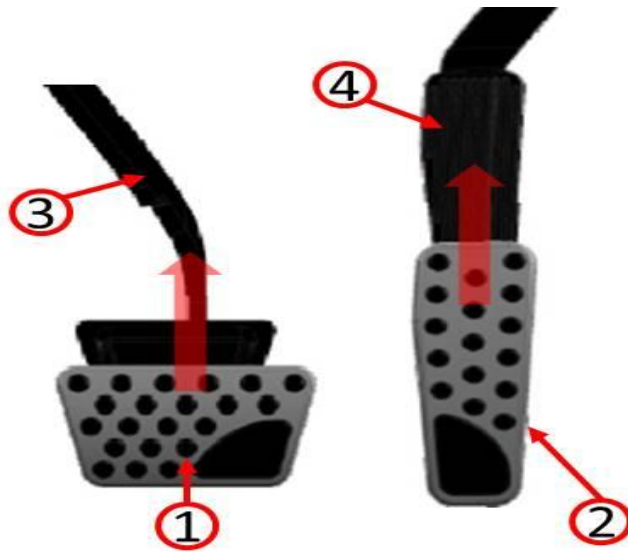
Fig. 6 Inserting Pedal Overlays

- 1 - Brake Pedal Insert
 - 2 - Accelerator Pedal Insert
 - 3 - Brake Pedal
 - 4 - Accelerator Pedal
-

7. Spray a soap and water mixture to the back of the pedal insert to ease installation and slide over the correlating pedal ([Fig. 6](#)).

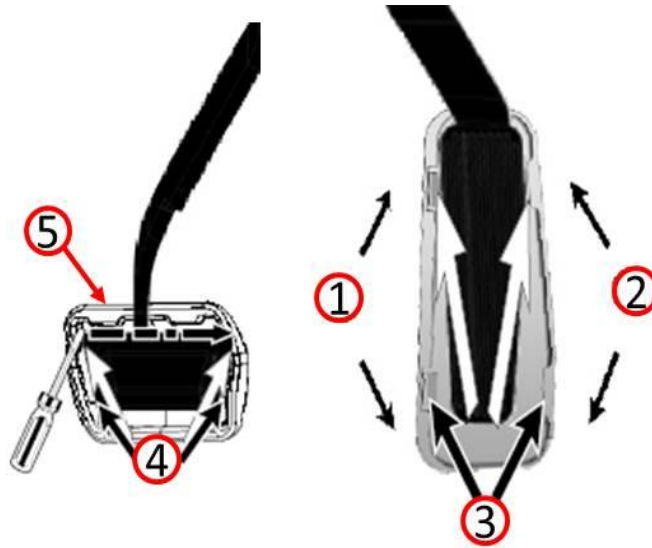
Fig. 7 Secure Pedal Inserts

- 1 - Locking Tabs
- 2 - Locating Tabs
- 3 - Accelerator Pedal Installation Direction
- 4 - Installation Direction
- 5 - Brake Pedal

- Using a flat blade screwdriver secure the locking tabs to the backside of the pedal (Fig. 7).
