NUMBER: 23-031-11

GROUP: Body

Outer Door Belt Weatherstrip Cracked And/Or Drooping Down

2008 - 2011 LC Challenger

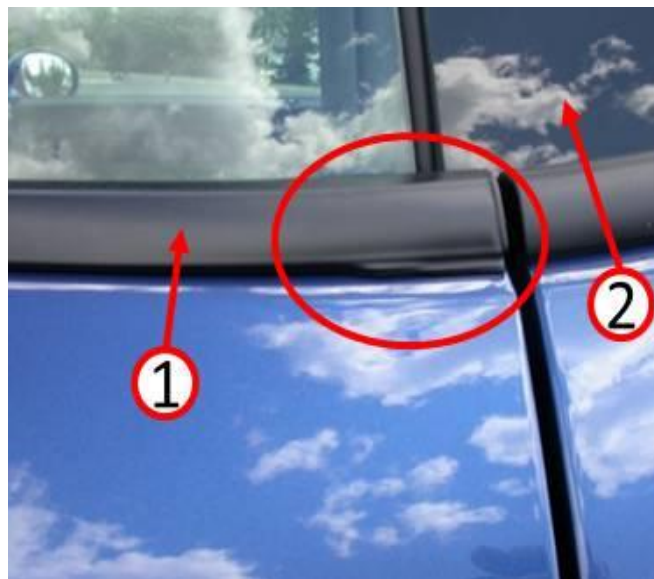
Fig. 2 Drooping Condition

- 1 - Outer Belt Weatherstrip
 - 2 - Quarter Window
-

1. Does the driver and/or passenger door outer belt weatherstrip appear to be cracked and/or drooping at the end near the quarter window (Fig. 1) & (Fig. 2)?
 - a. Yes >>> Proceed to [Step #2](#).
 - b. No >>> Further diagnosis required, this bulletin does not apply.
2. Remove both door outer and inner belt weatherstrips. Refer to the detailed procedures available in DealerConnect>TechCONNECT> under: Service Info> 23-Body> Door - Front> MOLDING> Removal.

NOTE: Due to appearance variation between original and revised parts, all door weatherstrips must be replaced with required parts listed.

3. Install revised door outer and inner belt weatherstrips. Refer to the detailed procedures available in DealerConnect>TechCONNECT> under: Service Info> 23-Body> Door - Front> MOLDING> Installation.
