NUMBER: 25-001-11

GROUP: Emissions Control

Incorrect Positive Crankcase Ventilation Valve (PCV) Installed

2011 (LC) Challenger

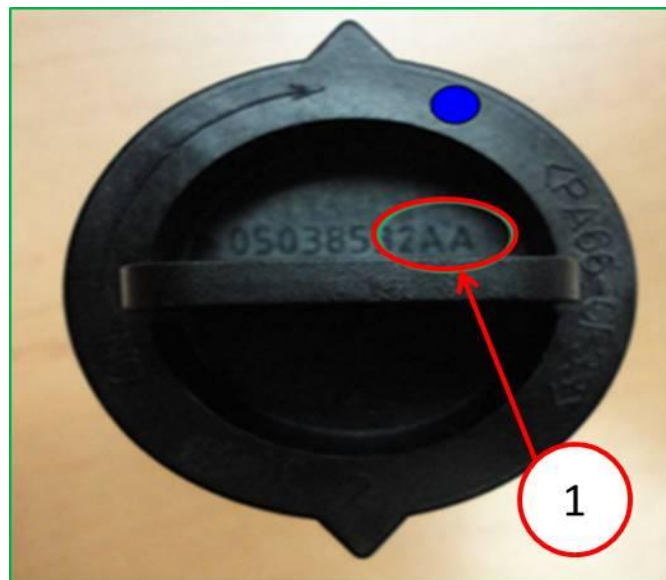
Fig. 2 PCV Part Number Location

2. Inspect the part number on the PCV valve. Part number is on top of the valve (Fig. 2).

1 - Part Number Location

NOTE: It may be necessary to clean the top of the PCV valve to read the part number.

- 3. Is the part number 05038532AA?
 - a. Yes >>> No further action is required. Return vehicle to Customer or Inventory.
 - b. No >>> Replace PCV valve. Follow detailed procedures in DealerCONNECT>TechCONNECT > 25 - Emissions Control > Evaporative Emissions > Valve, Positive Crankcase Ventilation (PCV) Removal and Installation. Dispose of the old part.
