NUMBER: 08-018-12

Flash: Hands Free Module Customer Satisfaction Enhancements

This Bulletin involves performing a USB service flash of the Hands Free Module (HFM).

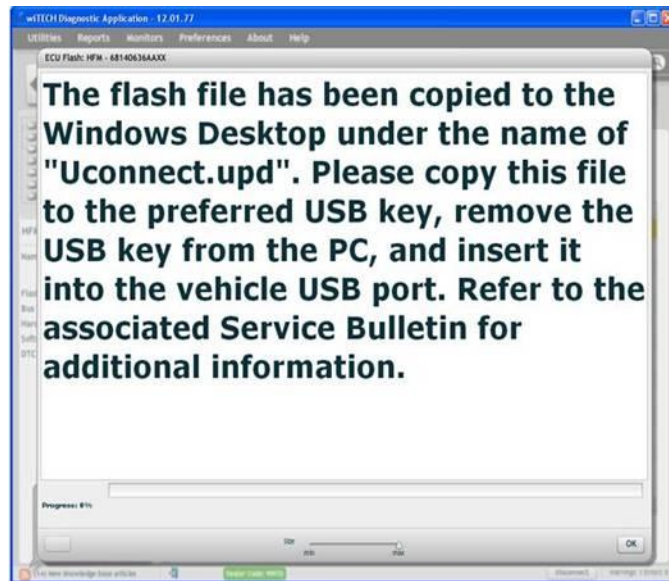
9. The Alternate Instructions dialog (Fig. 9) will appear.

Fig. 9 Alternate Instructions If Memory Stick Not Found

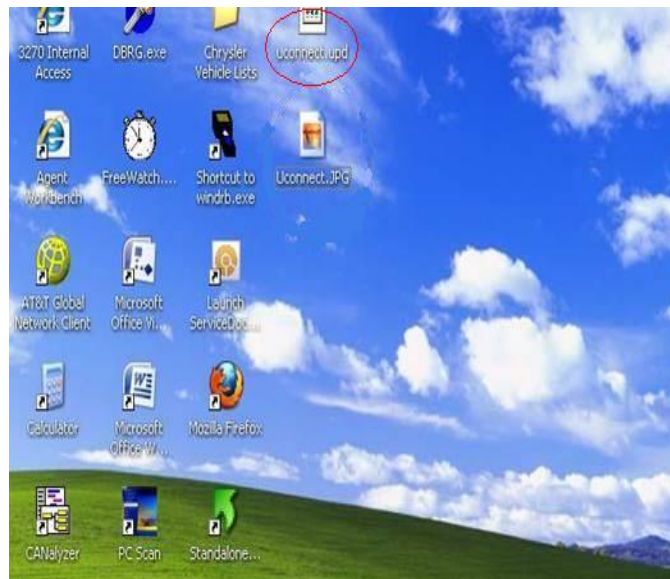
10. Insert a blank USB Memory Stick into a USB port on the wiTECH computer and then “drag and drop” the Uconnect.upd file from the computer desktop (Fig. 10) onto the blank USB Memory Stick.

Fig. 10 Sample Windows Desktop With Update File
