NUMBER: 08-036-11 REV. A

GROUP: Electrical

****Audio Device Compatibility Issues Including iPod and iPhone****

This Bulletin involves performing a USB service flash of the Hands Free Module (HFM).

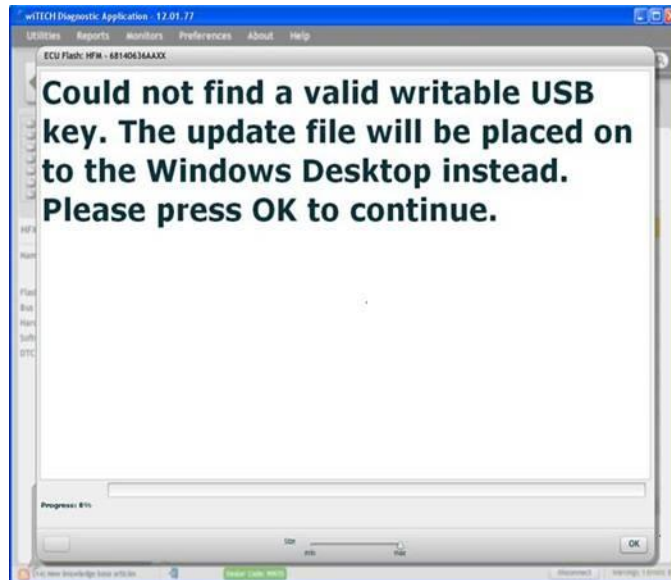
Fig. 8 USB Memory Stick Not Found

- 8. ****The USB Not Found dialog (Fig. 8) will appear. Click on OK to continue.****

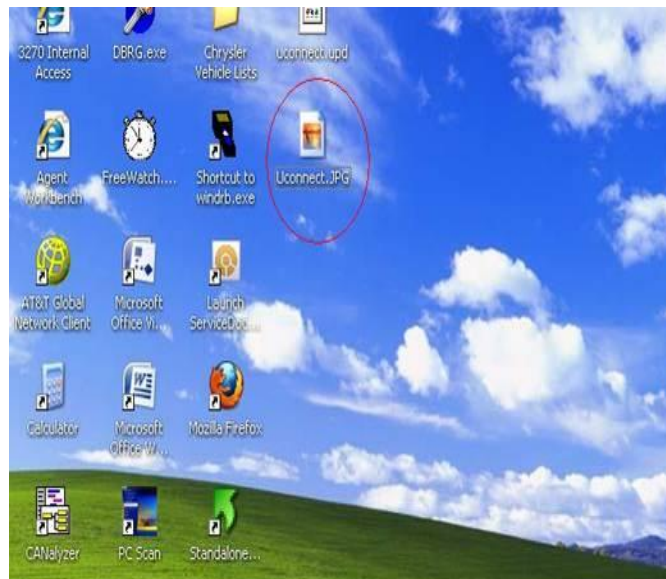
Fig. 10 Sample Windows Desktop With Update File

10. ****Insert a blank USB Memory Stick into a USB port on the wiTECH computer and then “drag and drop” the Uconnect.upd file from the computer desktop (Fig. 10) onto the blank USB Memory Stick. ****
