**NUMBER:** 23-018-10

**GROUP:** Body

Lower Door Hinges Make Popping or Groan When Opened Or Closed

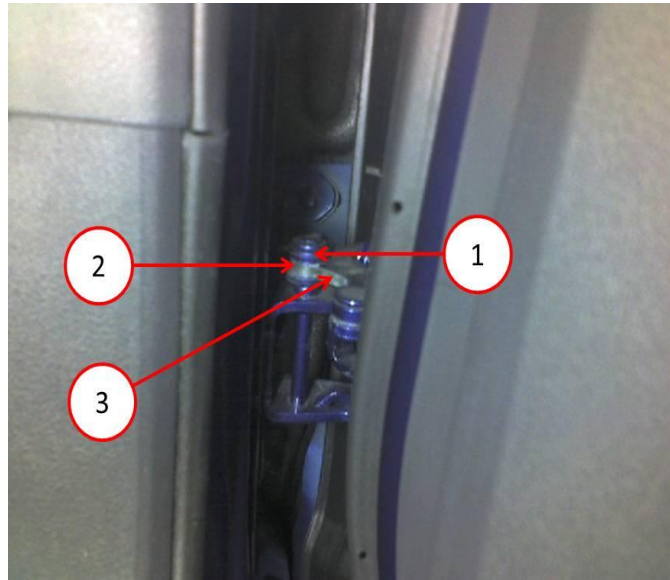
**Fig. 1 LOWER DOOR HINGE**

The lower door hinges make a moderate to loud popping/groan sound when the door is opened or closed.

This is due to the **roller axle** not being properly maintained with grease.

- 1 - ROLLER AND PIN (Spray Lube Here Only)  
 2 - ROLLER (Clean Excess Lube)  
 3 - ROLLER CAM (Clean Excess Lube)

1. Open door.
2. With straw installed on the lithium grease spray can (p/n 04318066AB), spray a very small amount of grease between the roller pin and inside roller surface (axle). (Fig. 1).

**CAUTION:** Be careful not to spray grease on the outside of the roller or roller cam. If grease is allowed to get on the outside of the roller or roller cam it must be cleaned off using a clean shop towel. Grease left on the outside of the roller and roller cam may also cause a noise.

3. Open and close the door 10 times to work the grease onto the roller axle.
4. Wipe away any excess grease in the sprayed area.
5. Repeat steps 1 through 4 for every door.
